GUIDELINES FOR DIVING SERVICE PROVIDERS inspecting vessels arriving to New Zealand

The New Rules – The Craft Risk Management Standard (CRMS) for Biofouling on Vessels arriving to New Zealand

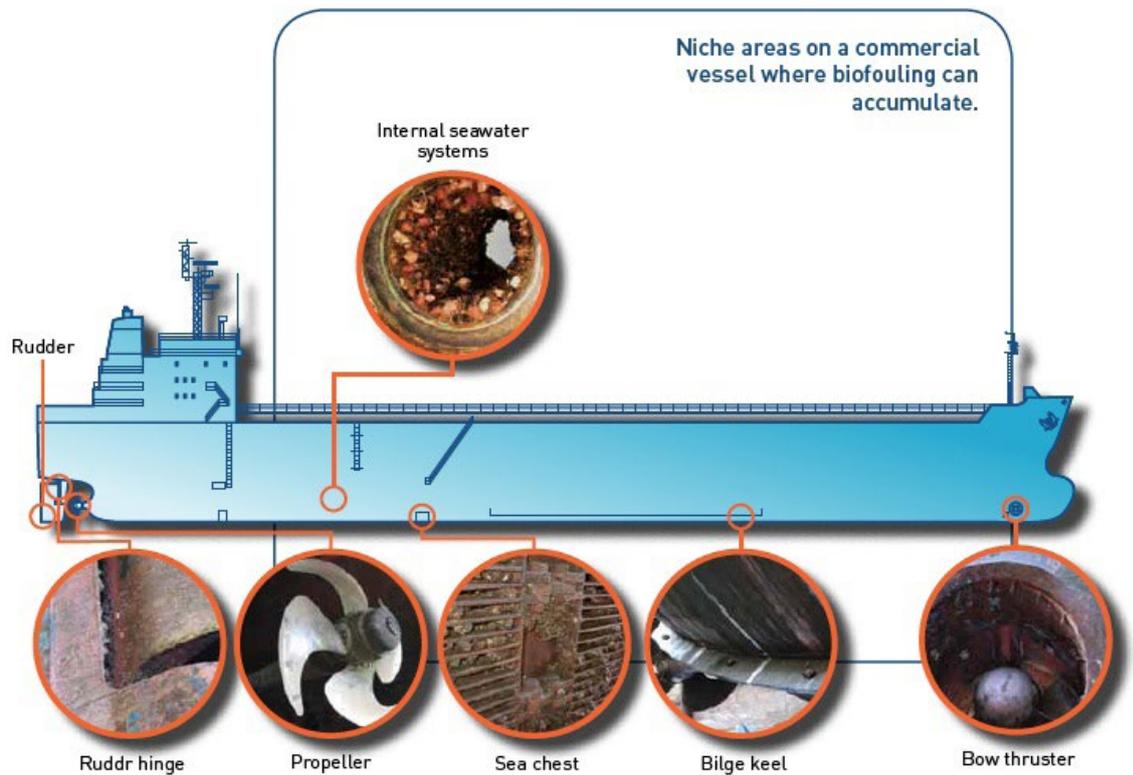
Niche areas where biofouling can accumulate, and which are important to document include, but are not limited to:

- Sea chests
- Bilge keels
- Bow/Stern thrusters
- Rudders
- Propellers
- Discharge pipes
- Bulbous bow
- Rope guards
- Sounders/instruments
- Sacrificial anodes, etc.

Vessel diagram provided by the Department of Agriculture and Water Resources

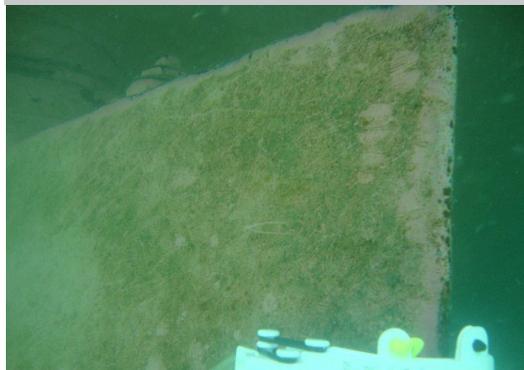
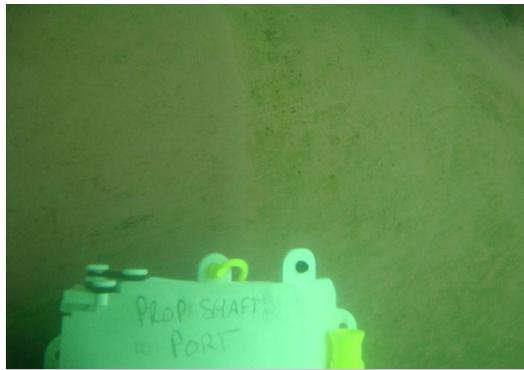
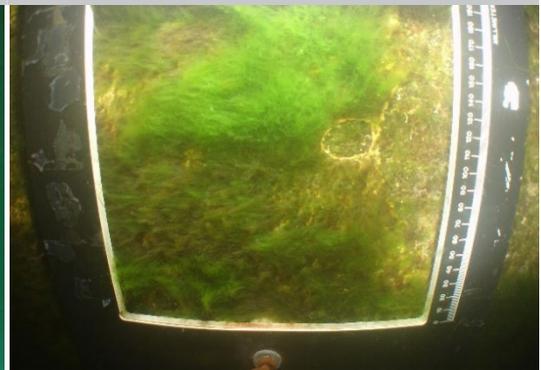
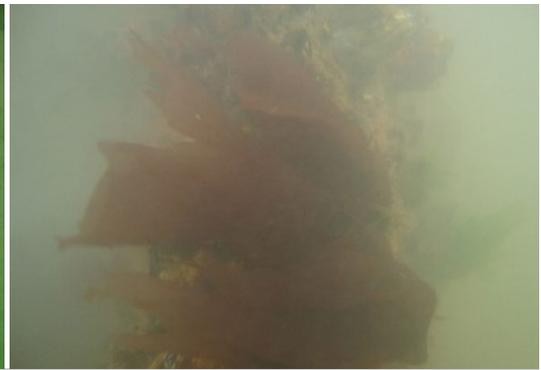
Slime layer

The slime layer should be flush with the hull and should not be filamentous or "roped". Macroalgae such as shown in the bottom, right hand photo does not count as "slime" and coverage greater than 1% on the hull or 5% in niche areas should be cleaned.

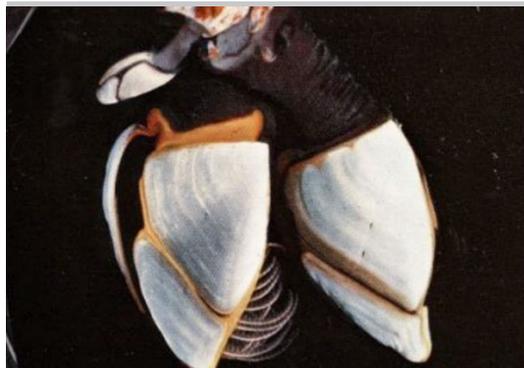
Gooseneck barnacles are always allowed under the CRMS, in any amount, in any location.

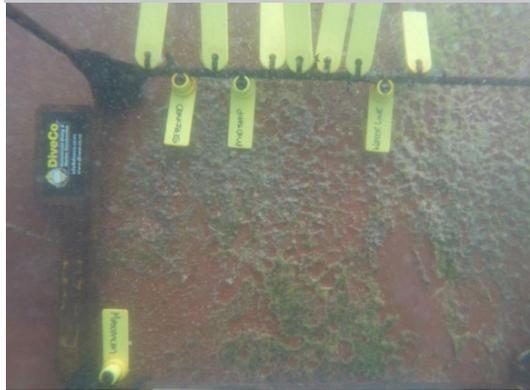
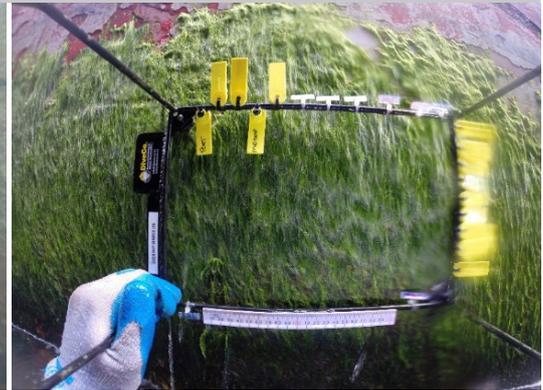
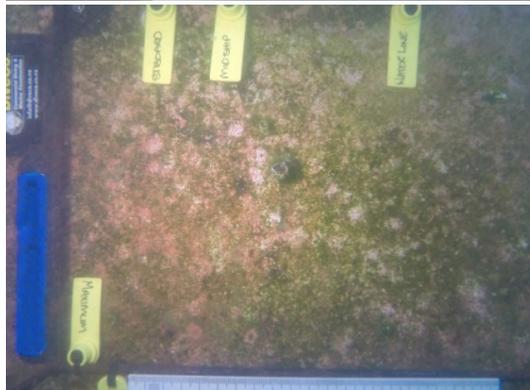
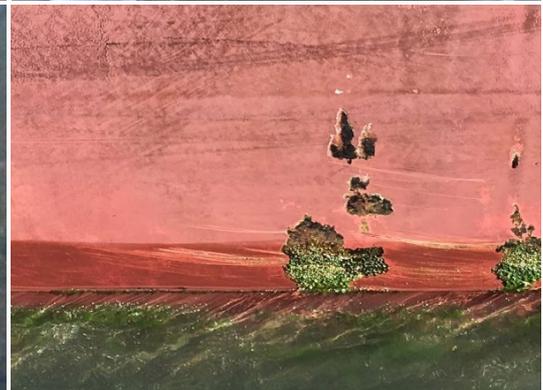
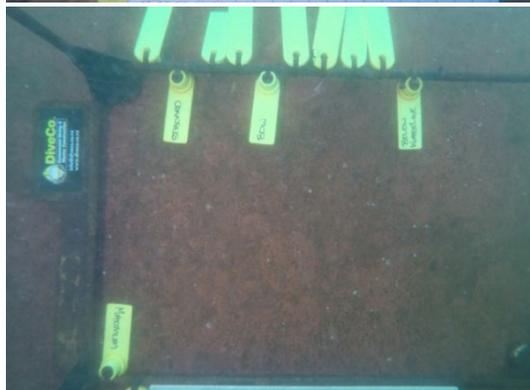
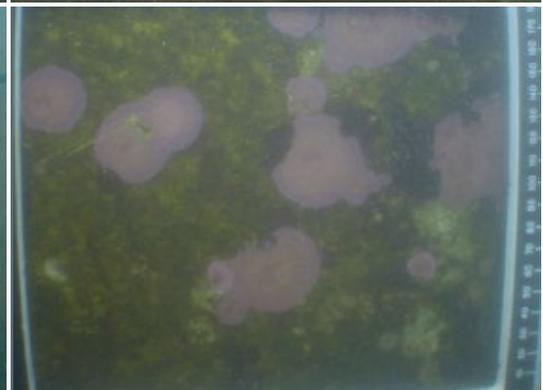
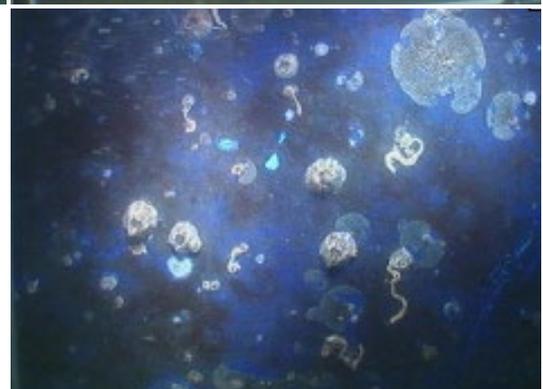
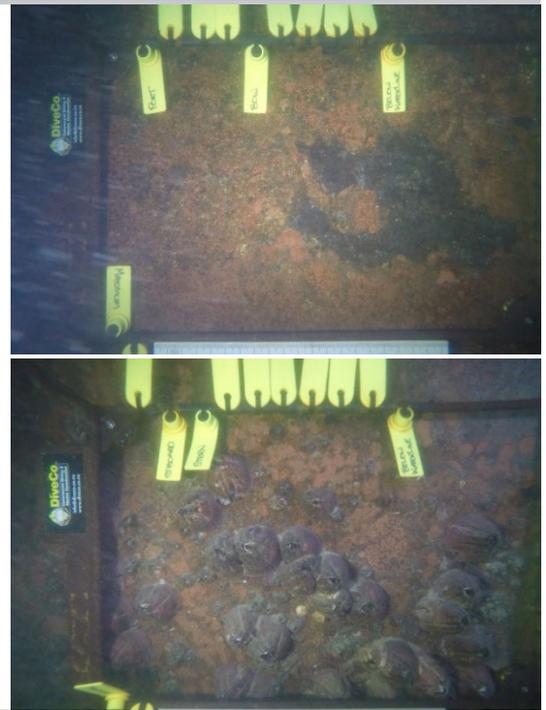
Waterline and flat hull surfaces

The waterline and flat surfaces of the hull should have no more than a slime layer and incidental (1% cover) of macrofouling. Filamentous slime is unacceptable, as are encrusting organisms such as bryozoans. Damage to the antifouling coating should be repaired, as a vessel with a damaged antifouling system is not following best practices for biofouling management. Scattered fouling presents a lower biosecurity risk than clumped fouling. Therefore, clumped biofouling and/or fouling of >1 organism type or species exceeds the thresholds and should be cleaned prior to the vessel's departure for New Zealand.

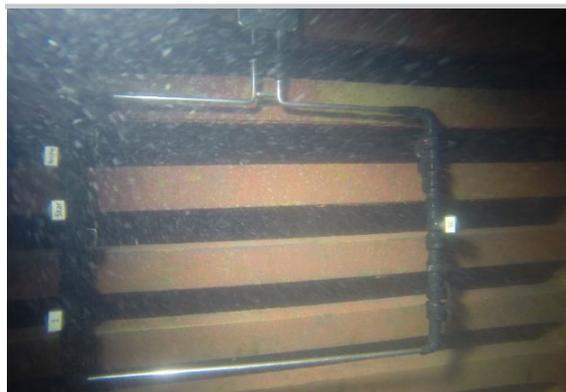
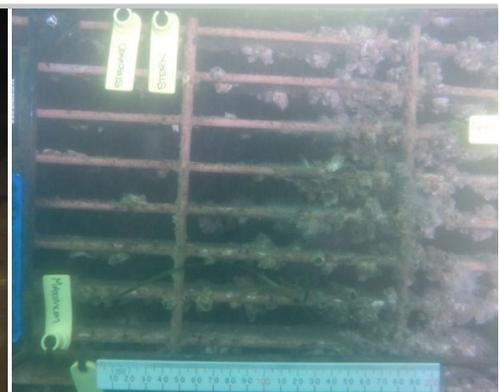
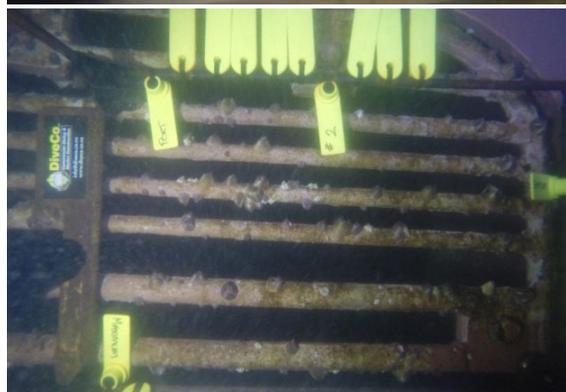
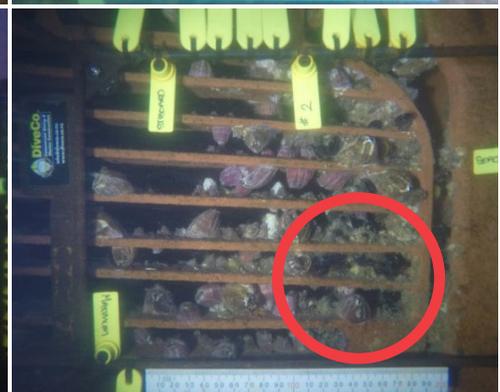
Sea chests should be unobstructed, with only scattered (<5% cover) macrofouling. Clumped macrofouling presents a higher biosecurity risk than scattered fouling (because the organisms are close enough to reproduce), so dense clumps or cover >5% should be cleaned. Mussels, such as those indicated in the circled portion of the bottom, right photo, are high risk organisms and indicate advanced fouling, and should always be cleaned when present. If possible, the insides of sea chests should also be inspected, documented, and cleaned if necessary.

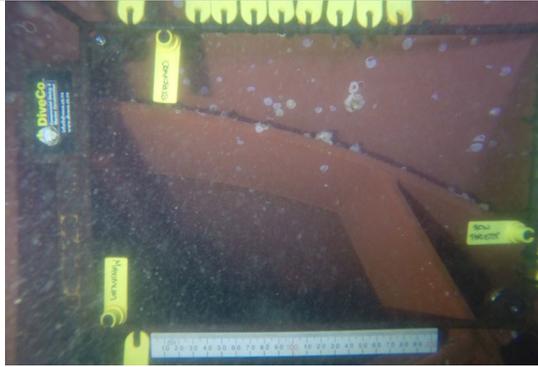
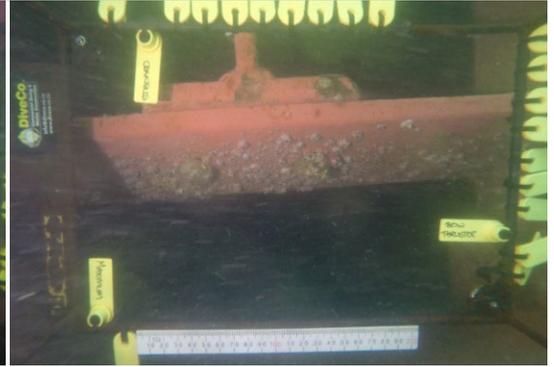
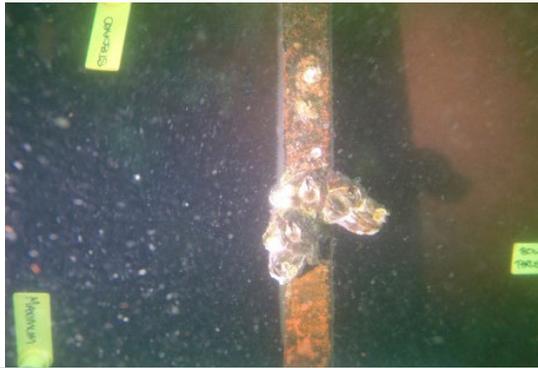
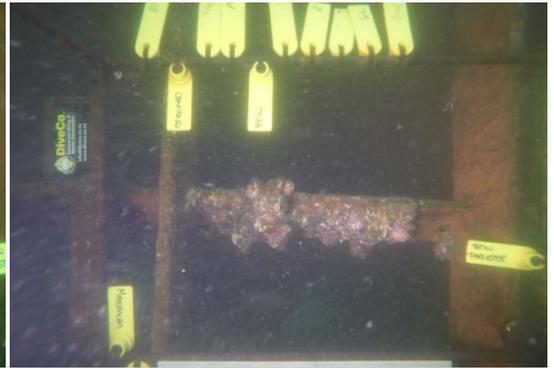
Bow thrusters

Niche areas should have a total biofouling cover of <5%, plus a slime layer and gooseneck barnacles. All fouling organisms, including encrusting and soft-bodied organisms, should be included as part of the total estimate of cover. All niche areas should be thoroughly inspected and photographed, with attention to recesses and other irregularities which may shelter biofouling organisms. All niche areas present on the vessel should be inspected and documented during the hull inspection, if possible (note, the below section is not a comprehensive list of niche areas to be surveyed).

Any biofouling above the 5% cover threshold should be cleaned, with special attention to organisms growing in clumps, or to organisms such as mussels, which indicate advanced levels of hull fouling and present a higher biosecurity risk.

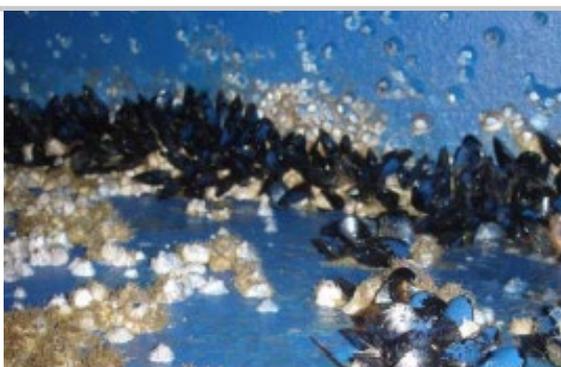
Although the CRMS thresholds are based on total percent cover, rather than on the species present, some biofouling organisms are indicative of advanced hull fouling, and should always be removed when present. The presence of these organisms not only increases the biosecurity risk associated with the vessel, but also indicates that the vessel has likely not been managing biofouling using best practices. If these organisms are present on the vessel, there is a high possibility that the vessel will be found non-compliant with the CRMS.

<p>Mussels</p>

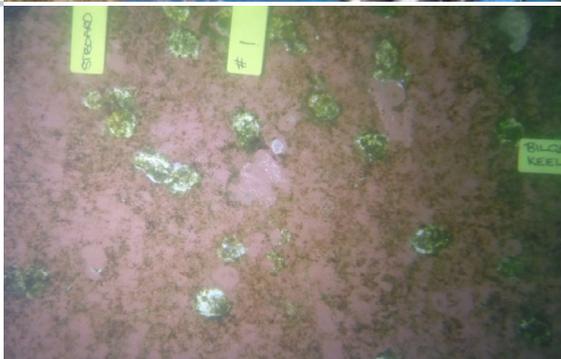
<p>Oysters</p>

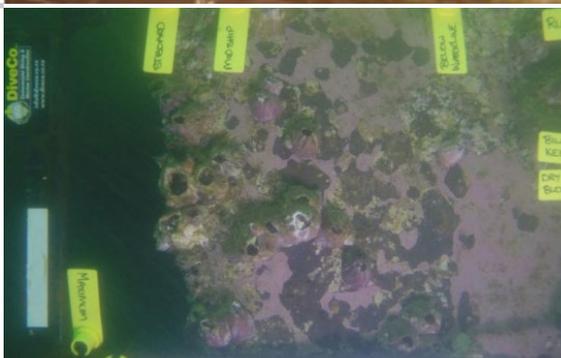
<p>Slime, algae, or barnacles growing on top of other fouling organisms (indicates advanced fouling assemblage)</p>
